PlanSwift Slow Screen Refreshes in Citrix

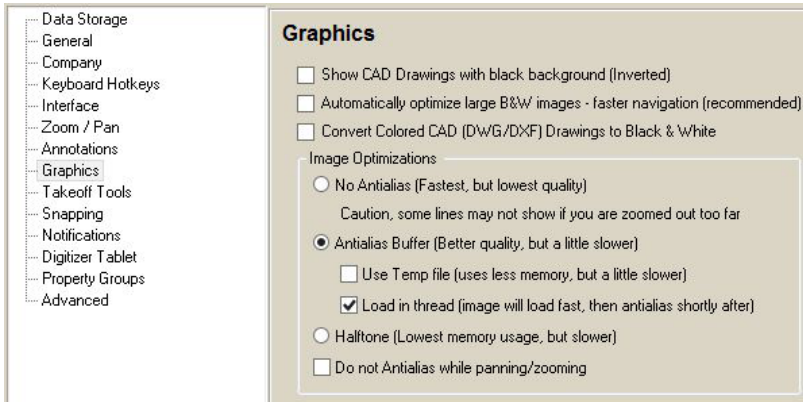
When using PlanSwift takeoff software inside of a Citrix session, the refresh/redraw rate may appear slow, particularly over low-bandwidth Internet connections.

1. Click on **Settings** (located in the ribbon bar) and select **Graphics** in the left tree view.
2. Adjust the Image Optimizations options. The recommended selection is Antialias Buffer with Load In Thread only checked, but the No Antialias option might be faster for some users.
